**DRAFT FINAL REMEDIAL ACTION SITE CLOSURE REPORT
OPERABLE UNIT 3, INSTALLATION RESTORATION SITE 1E
32 AREA REFUSE-BURNING GROUND
MARINE CORPS BASE
CAMP PENDLETON, CALIFORNIA**

**Environmental Remedial Action
Contract No. N62474-98-D-2076
Contract Task Order 0080**

**Document Control Number 6505
Revision 0**

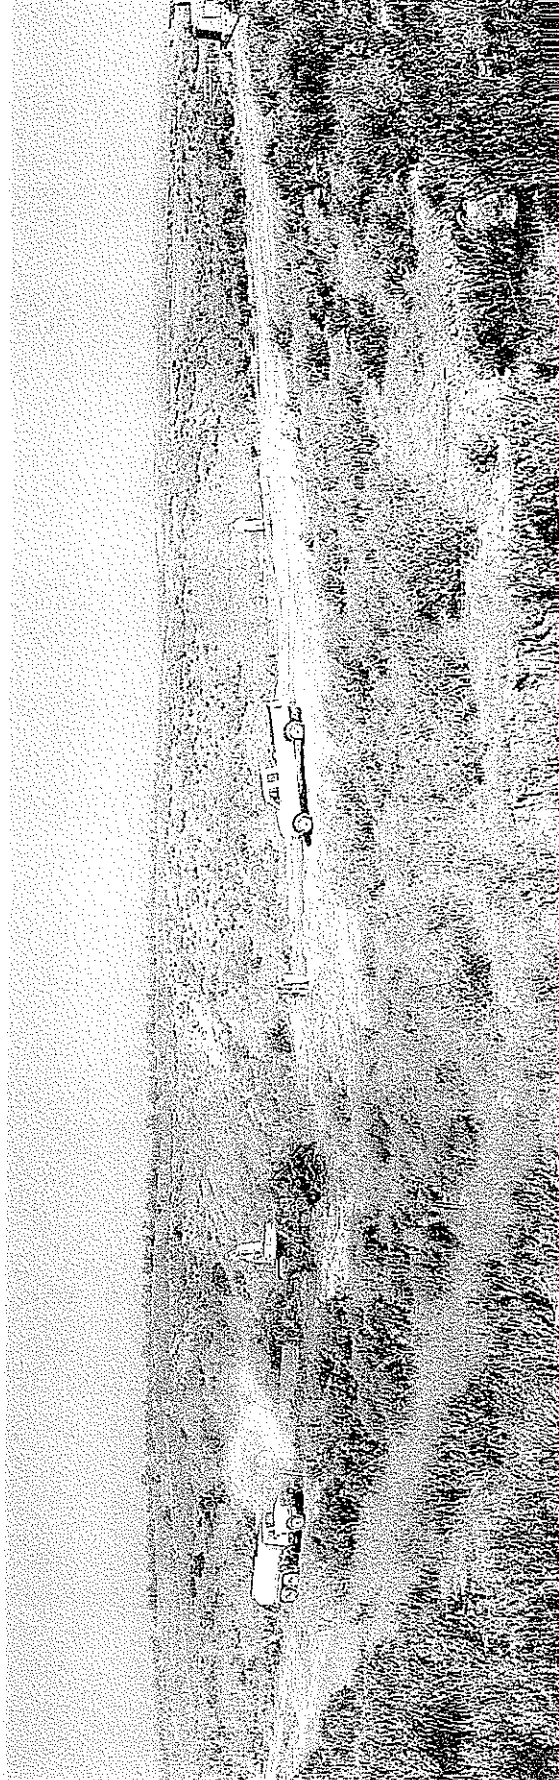
Photograph No. 2: Site 1E Clearing And Grubbing (August 18, 1999)
PCL # 1

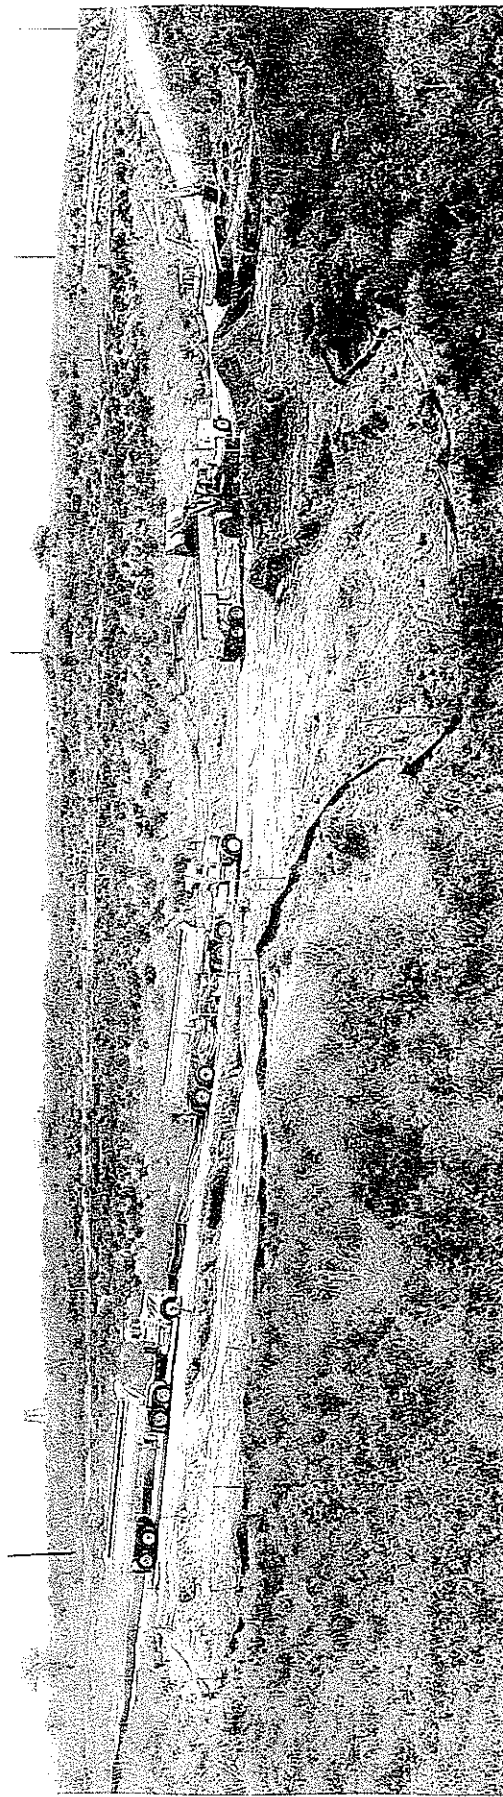
Photograph No. 4: Last Day of Loading Contaminated Soil from Planned Excavation for Transport to CAMU (August 27, 1999)
PCL # 3

fashion until August 27, 1999, when the planned excavation depth for the site was completed. At this stage, about 2,100 cubic yards of contaminated soils were removed. Visual inspection of the site indicated that the burn debris or waste extended deeper and farther than the planned boundary. The interim floor confirmation sampling results (Table 3-2) indicated that the contamination was still significant throughout the excavated area. Overexcavation would be required to remove the contamination.

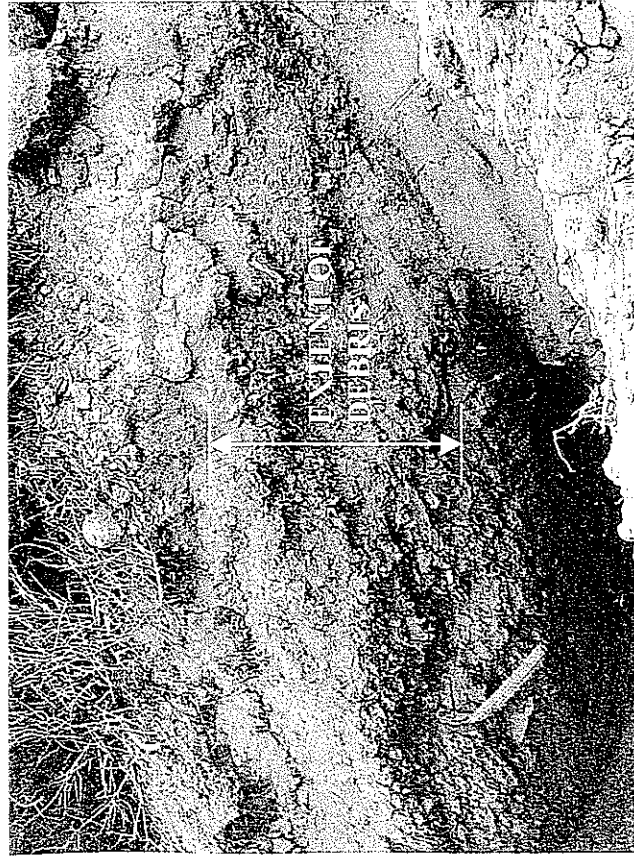
Photograph No. 6: View of Debris During Trenching

Prior to beginning full-scale overexcavation, multiple test trenches were dug between September 3 and 9, 1999 to assess the extent and depth of the debris area. The trenching investigations revealed that wastes were present in the slope and the ravine area of the stream-cut canyon immediately to the west of the burn area (see trenching locations and conditions on pictures in Appendix B). The characteristics of the burn ash and debris found along the slope were consistent with those encountered during the planned excavation. The depth of debris encountered during the trenching also greatly exceeded the initially established planned excavation depth of 3 feet (some trenches were as deep as 20 feet in the ravine).

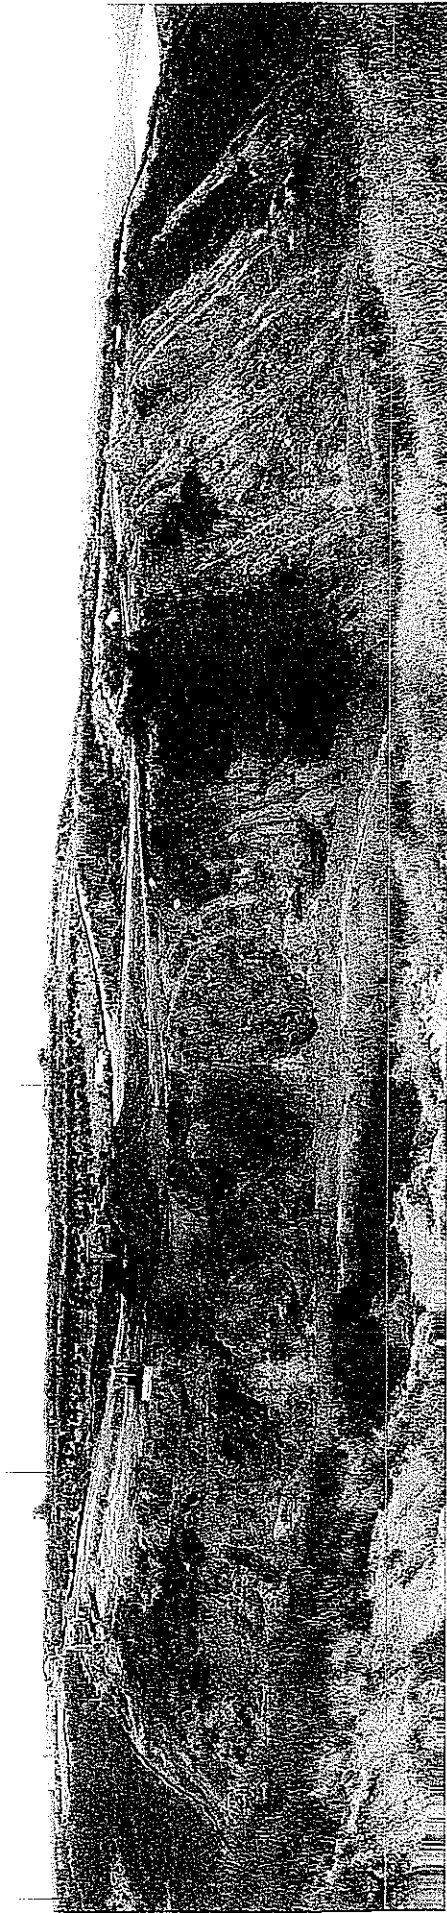
Photograph No. 8: Site 1E First Day of Overexcavation Activities Outside Planned Boundary (September 17, 1999)
PCL # 3

Full-scale overexcavation began on September 14, and was continued into November 19, 1999. Additional equipment and haul roads were required to effectively remove and transport contaminated soil from the slope. The burn debris was excavated until the surface soil was visibly clean. A new confirmation sampling grid system (Figure 3-3) was established to cover the overexcavated area. Because the area of excavation was expanded considerably, the new sampling grid increased the space between grid points from 30 feet to 67 feet. Additional soil samples were collected once the excavated surface was visually clean. The overexcavation was conducted in this fashion until the extent of contamination was confirmed and a new site boundary was established.

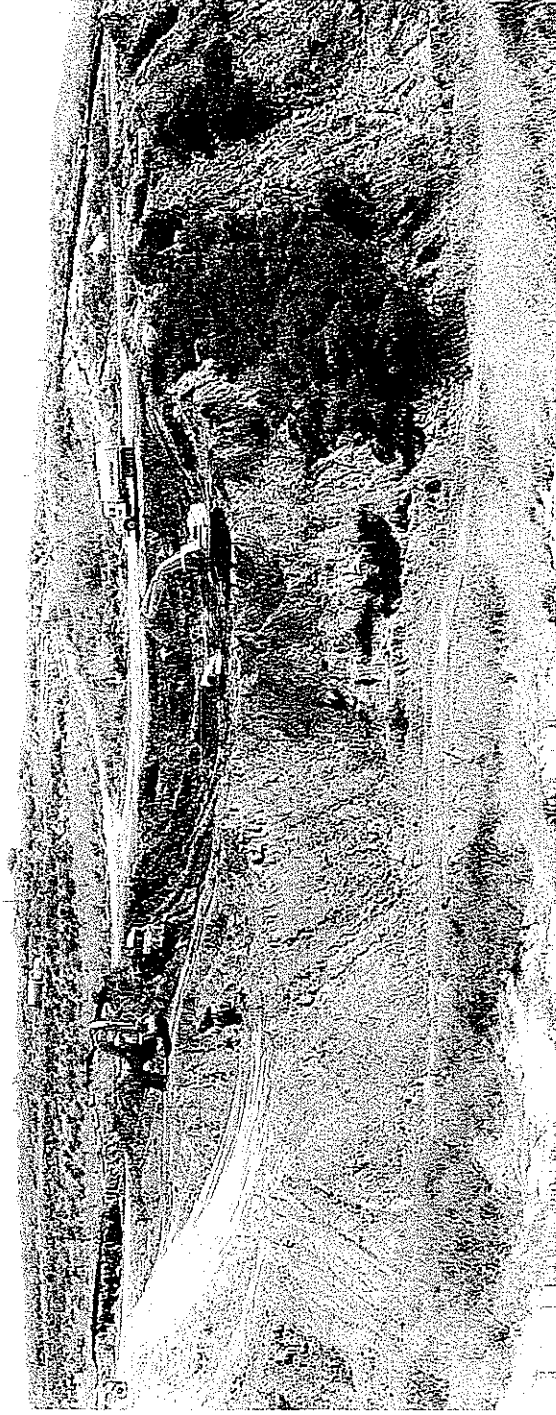
Photograph No. 9: Site 1E Overexcavation and Stockpiling Operations (September 22, 1999)
PCL # 3

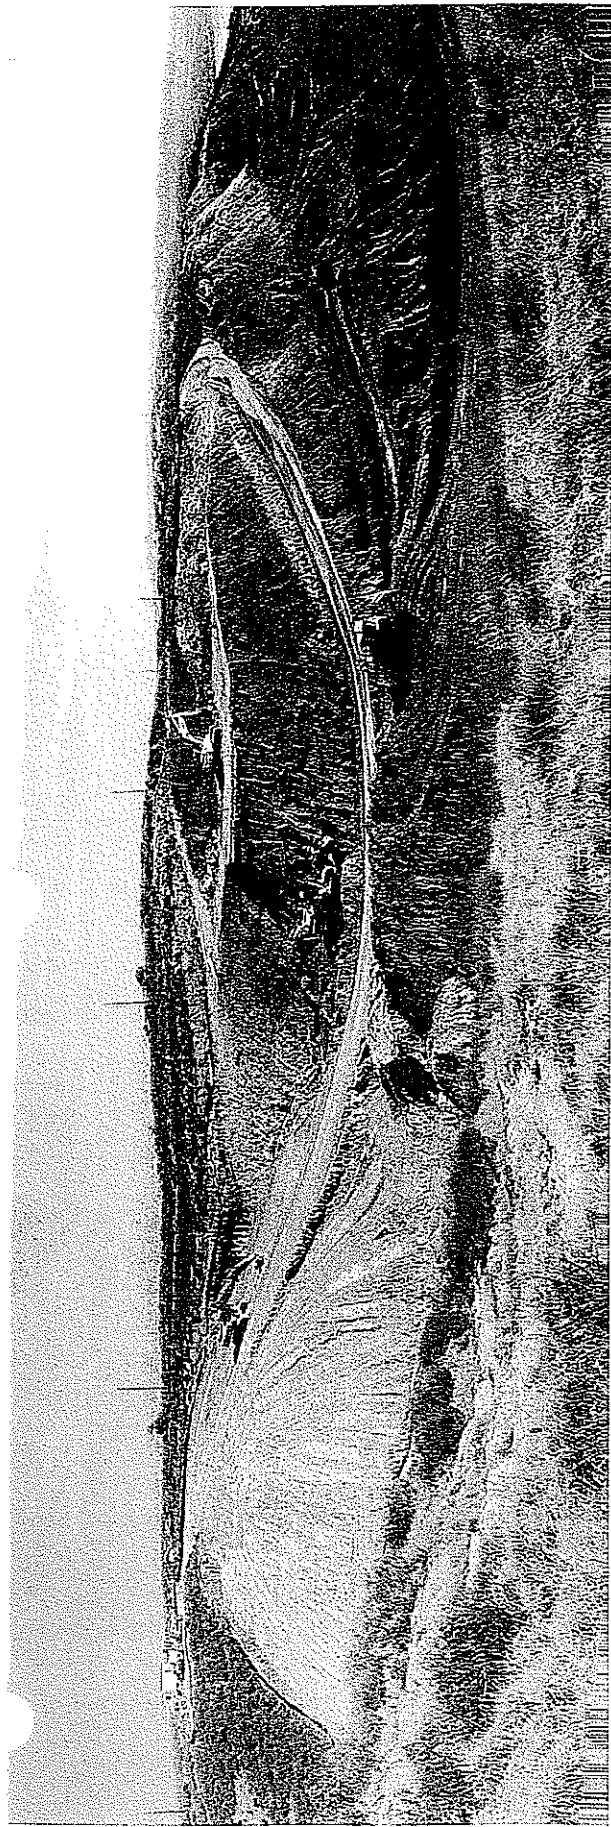
Photograph No. 14: Site 1E Overexcavation Activities in Progress (October 22, 1999)
 PCL # 3

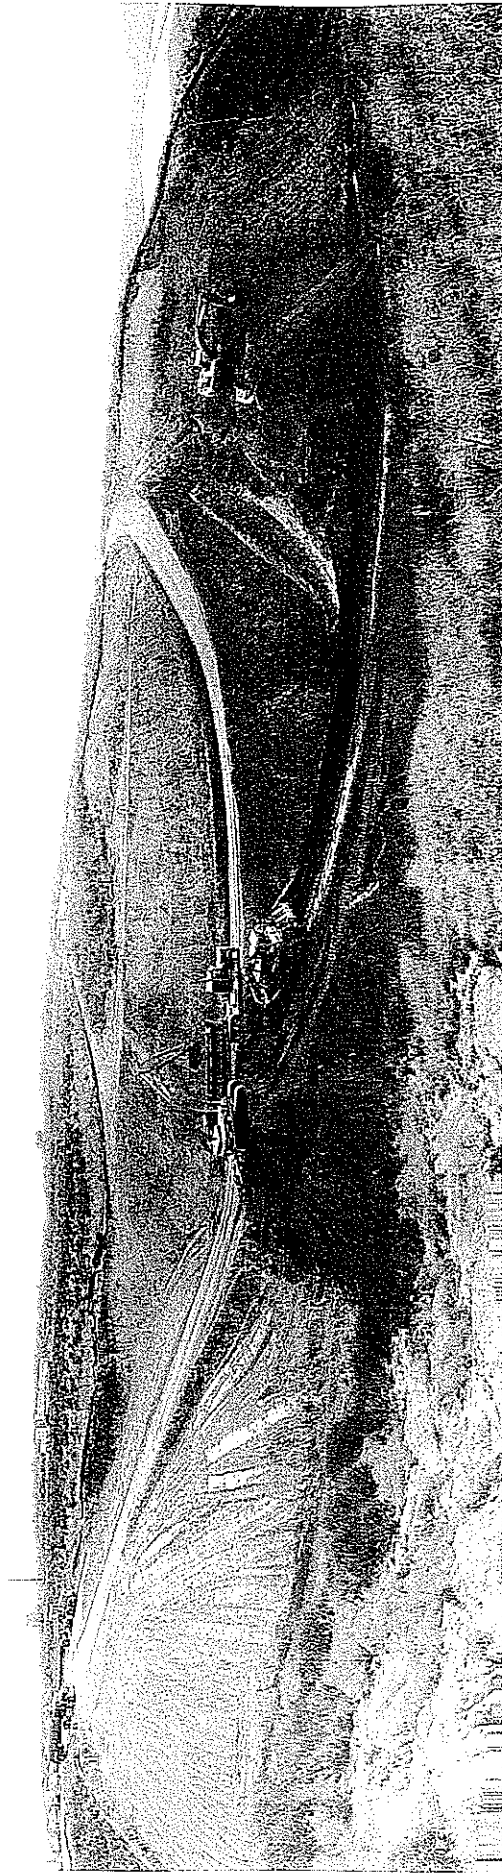
Photograph No. 15: Site 1E Overexcavation of Canyon Floor (November 5, 1999)
 PCL # 3

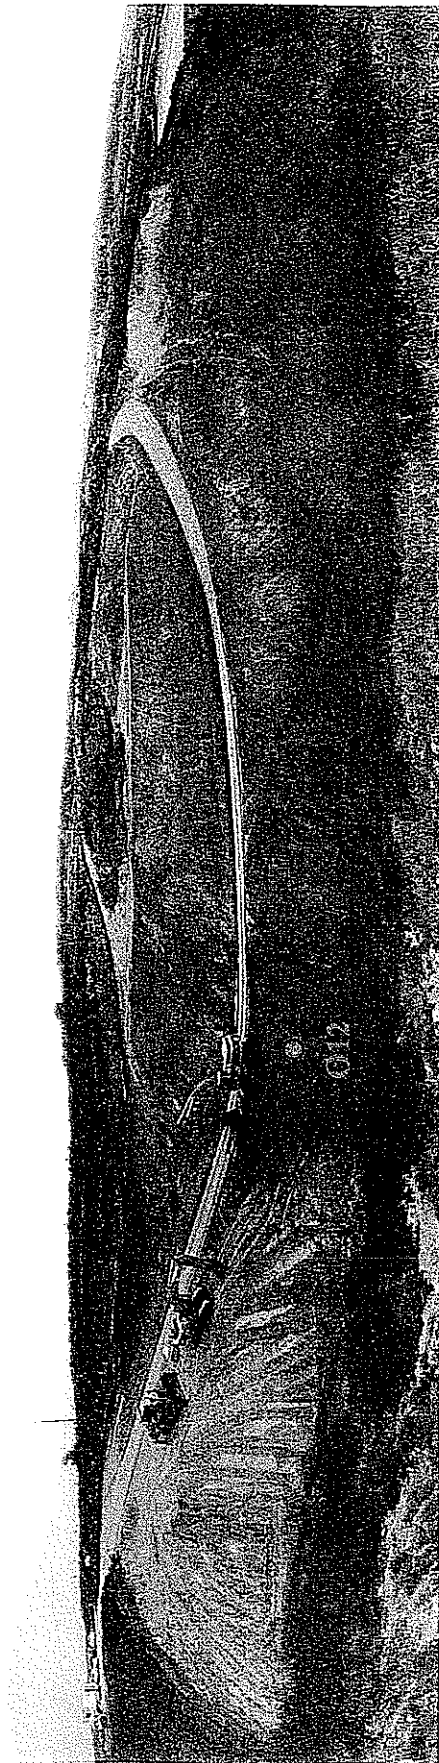
Photograph No. 17: Site 1E Overexcavation Activities for 1999 Completed (November 19, 1999)
PCL # 3

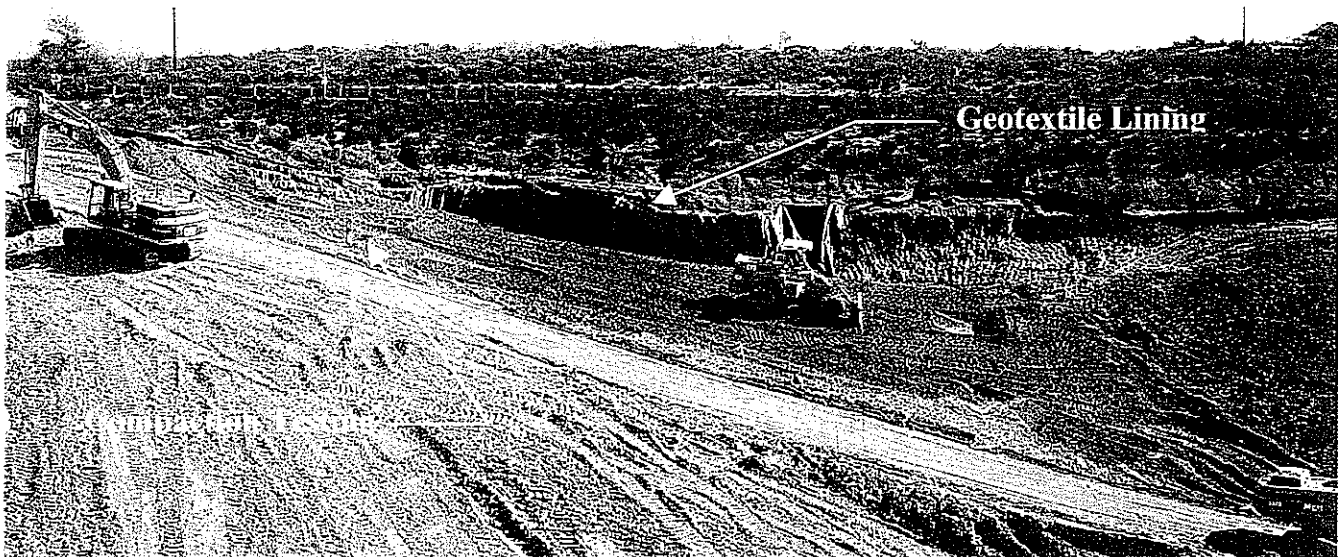
Photograph No. 19: Site 1E Backfilling, Compacting, and Testing (December 01, 1999)

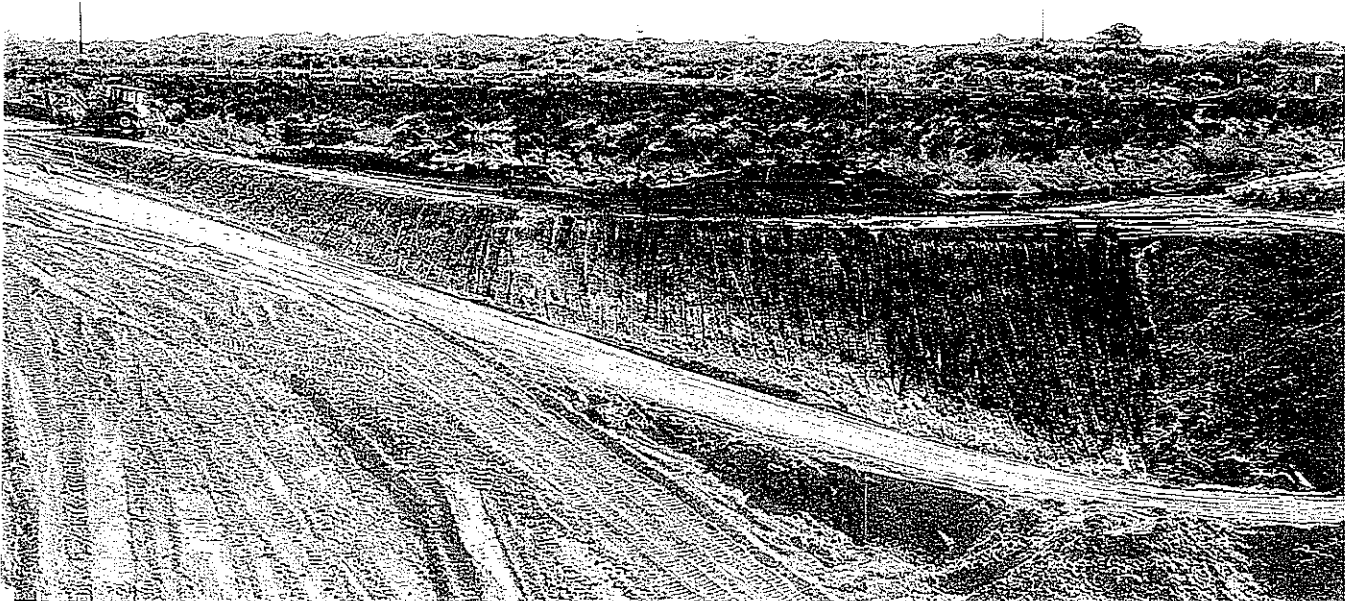
Photograph No. 20: Site 1E Backfilling and Grading Completed (December 08, 1999)

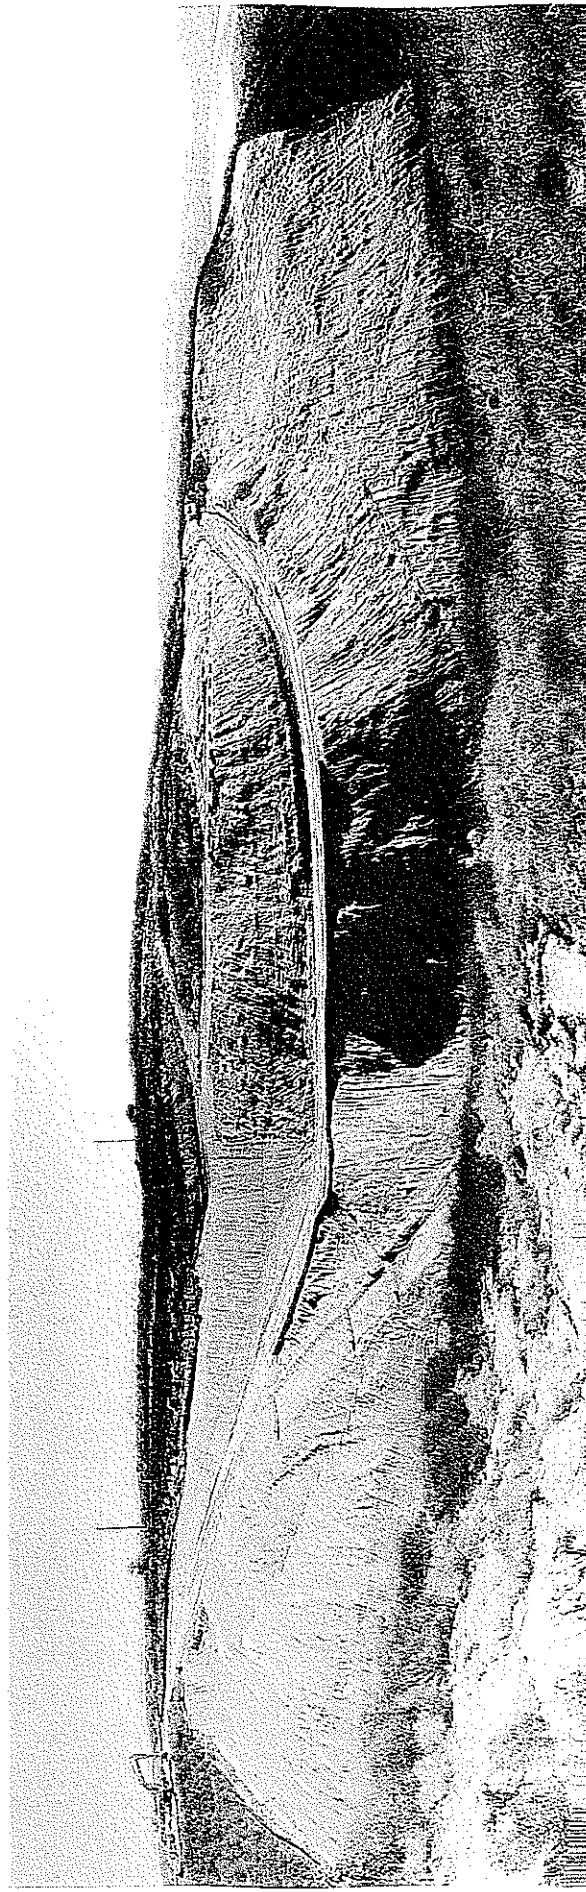
Photograph No. 22: Site 1E Winterization Installation Completed (December 17, 1999)
PCL #3
